Manhole Inspection Summary

Manhole # S55A__020MH

Insp Date: **6/24/08 8:48 AM**

Location Address: **rear 3600 e fayette st**

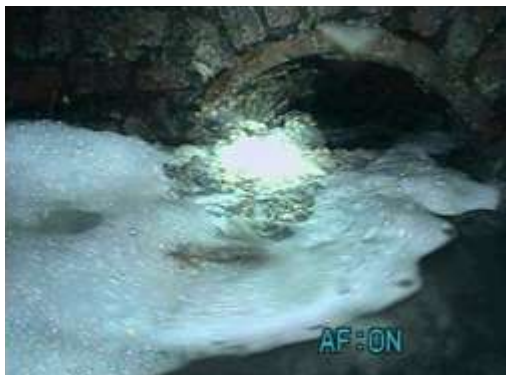
Defect 5

Condition: ☐ Sound ☐ Cracked ☐ Root Intrusion ☐ Deteriorated ☐ Leaks ☒ **Debris**

channel debris

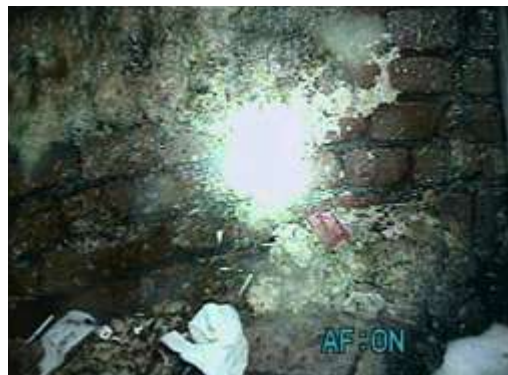
Defect 4

Condition: ☐ Sound ☐ Cracked ☐ Root Intrusion ☐ Deteriorated ☐ Leaks ☒ **Debris**

bench debris

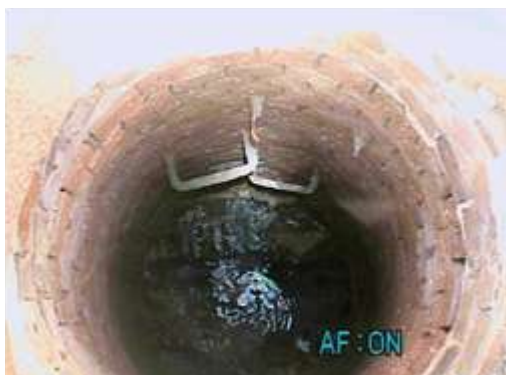
Defect 3

Steps Count: **4** Missing: **1** ☒ **Corroded**

missing & corroded steps

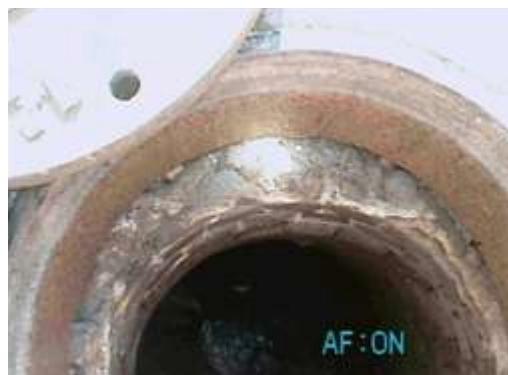
Defect 2

Frame Offset: **4** (in.) Condition: ☒ Sound ☐ Cracked ☐ Leaks

frame offset

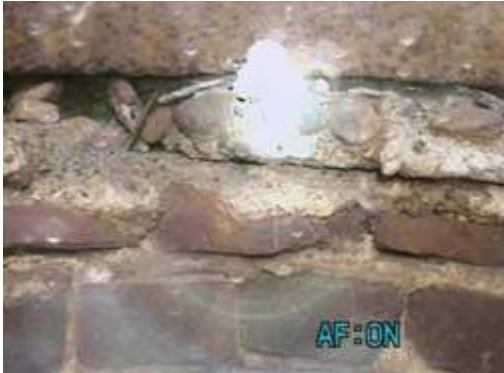
Defect 1

Condition: ☐ Sound ☐ Cracked ☐ Root Intrusion ☒ **Loose Brick** ☒ **Deteriorated**

chimney loose bricks, deteriorated frame
adj

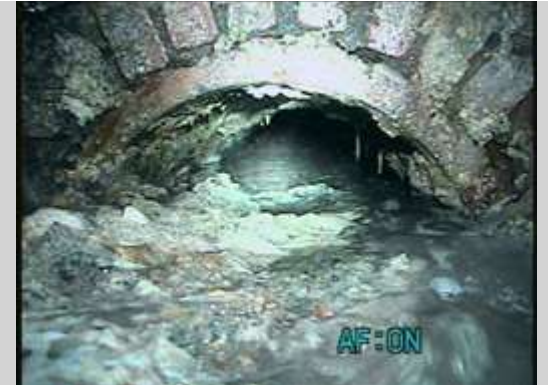
12 O'Clock Outflow

21 in. Circular Gravity Sewer
Pipe Out @ 12 OClock

Pipe Height: **0** (in.) Direct
Pipe Material: **Clay** ☐ Pipe Lined
Invert Depth: **11.11** (ft.) Flow Characteristics: **Fast**
Deposits: ☐ None ☐ Mud ☐ Gravy ☒ Debris ☐ Grease
Silt Depth: **6** (in.) Deposits Extent: **Heavy**
Infiltration: **None** Pipe Seal Cond: **Unknown**

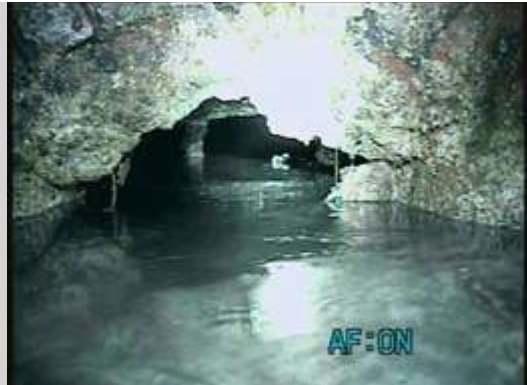
6 O'Clock Inflow

Deposits: ☐ None ☐ Mud ☒ Sludge ☐ Debris ☐ Grease

Silt Depth: 6 (in.) Deposits Extent: Medium

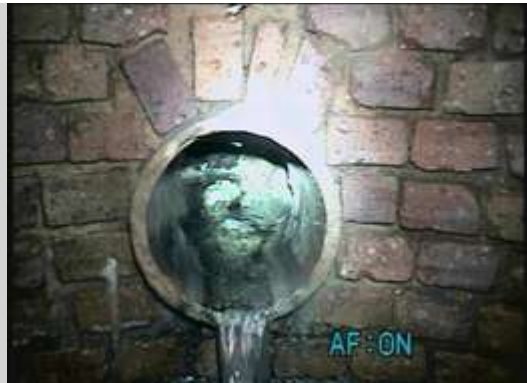
9 O'Clock Inflow

Deposits: ☐ None ☐ Mud ☐ Sludge ☒ Debris ☐ Grease

Silt Depth: 7 (in.) Deposits Extent: Heavy

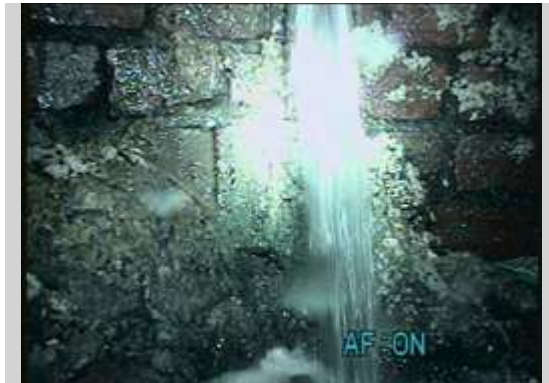
Drop In @ 9 O'Clock

Drop: Outside Direct

Drop Condition: Clogged
